JOINT TASK FORCE SEVEN
TASK GROUP 7.3
APO 187, c/o Postmaster
San Francisco, California

22 March 1954

Subj: Radioactive Contamination of Ships and Radiological Exposure of Personnel of Task Group 7.3 due to BRAVO, the First Nuclear Explosion of CASTLE

- Encl: (1) Diagram indicating positions of TG 7.3 ships from H hour until about 0815, 1 March 1954.
(2) Tabulation of average topside radioactive intensities of Task Group 7.3 ships, at various times following BRAVO.
(3) Tabulation of accumulated radiological exposures of Task Group 7.3 personnel by ships and units.
(4) BAIROKO (CVE 115) secret serial 0010 of 11 March 1954.

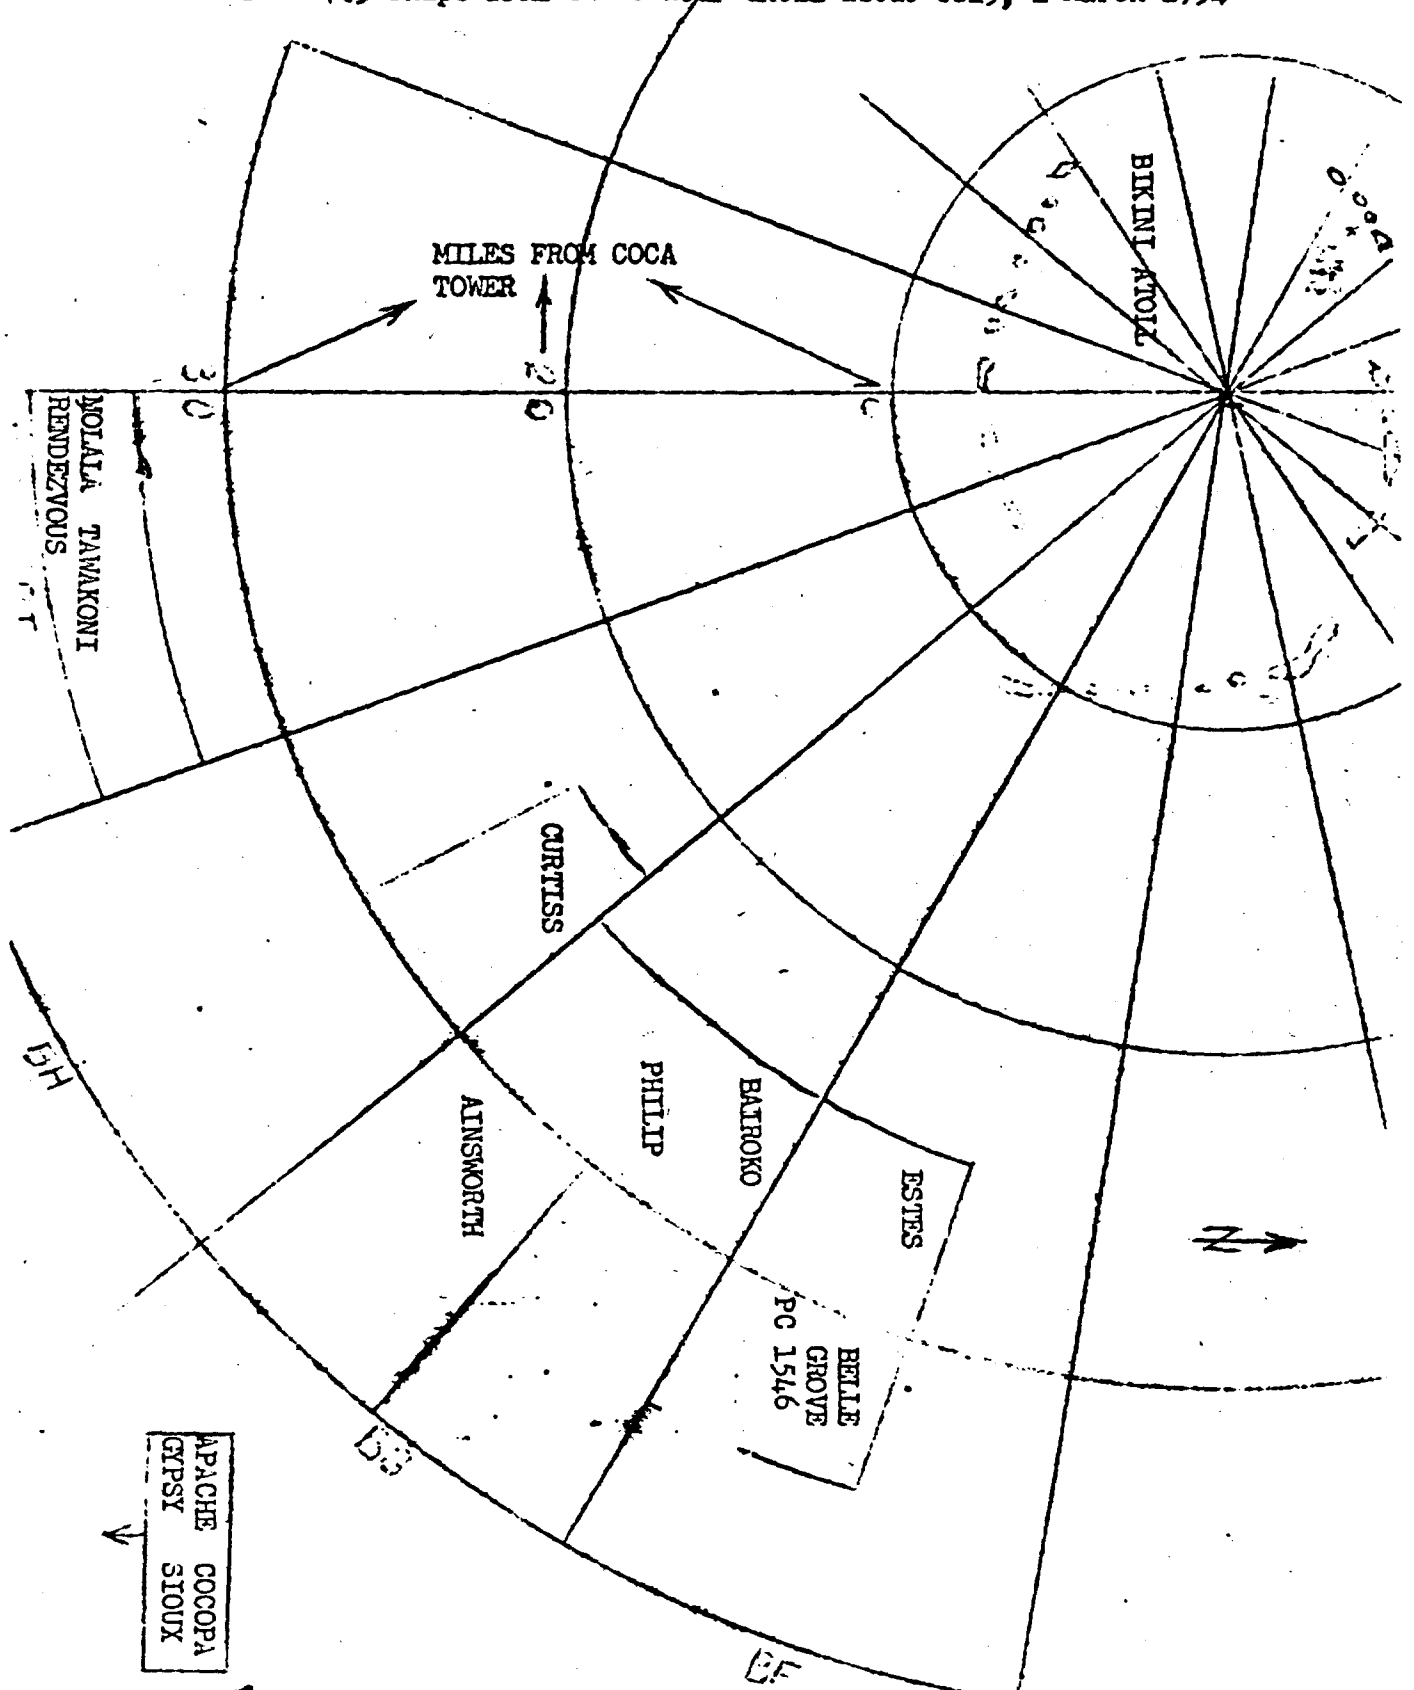
ENCL (1)

1. On 1 March 1954, at 0645M, the first nuclear explosion (BRAVO) of Operation CASTLE was detonated. Prior to the detonation, ships of Task Group 7.3 had been deployed at sea generally in the southeast quadrant from ground zero as indicated in enclosure (1). This disposition and its location were based on four principal factors, (a) the latest CJTF SEVEN radex, (b) the requirements of the Commander Scientific Task Group (CTG 7.1) that ESTES (AGC 12) and CURTISS (AV 4) be positioned about 12 miles from ENYU Island for reliable UHF communications and Raydist purposes, (c) the requirement that ships be disposed at safe distances (at least 30 miles) from ground zero to avoid harmful heat, and blast effects, and (d) the requirement of reasonable concentration for communications and control purposes. Prior to the detonation and because later wind data began to indicate an easterly component, some of the smaller and slower units were directed to move to the south, but the larger ships were retained in the localities indicated in view of the foregoing requirements (b) and (d) and the expressed desire of the JTF Commander that they not be moved. Because of the additional requirements for early helicopter survey trips and the early dispatch by helicopter of an emergency airfield crew for the airfield on ENINMAN Island, the large ships were retained generally in their pre-shot positions after the detonation until about 0800M, when sudden and rapidly increasing radioactive fallout was detected on some ships. At this time, all ships were ordered to take all possible radiological defense damage control measures, including the employment of washdown systems, and to proceed to the south at best speed.

Positions of TG 7.3 ships from BRAVO Hour until about 0815, 1 March 1954
