AN
INSPECTION REPORT
OF
WEATHER AND RAD-SAFE STATIONS

30 July Thru 3 August 1959

From: E. H. Willes, Resident Engineer Re: Report and Log of Inspection of
[Signature] Weather and Rad-Safe Stations at
Ujelang, Ponape, Kapingamarangi
Kusaie, Utirik, and Wotho.

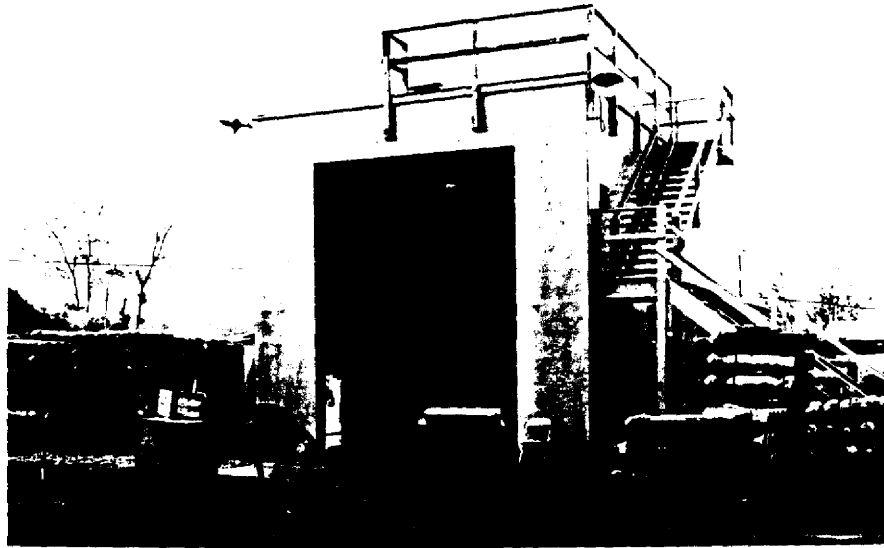
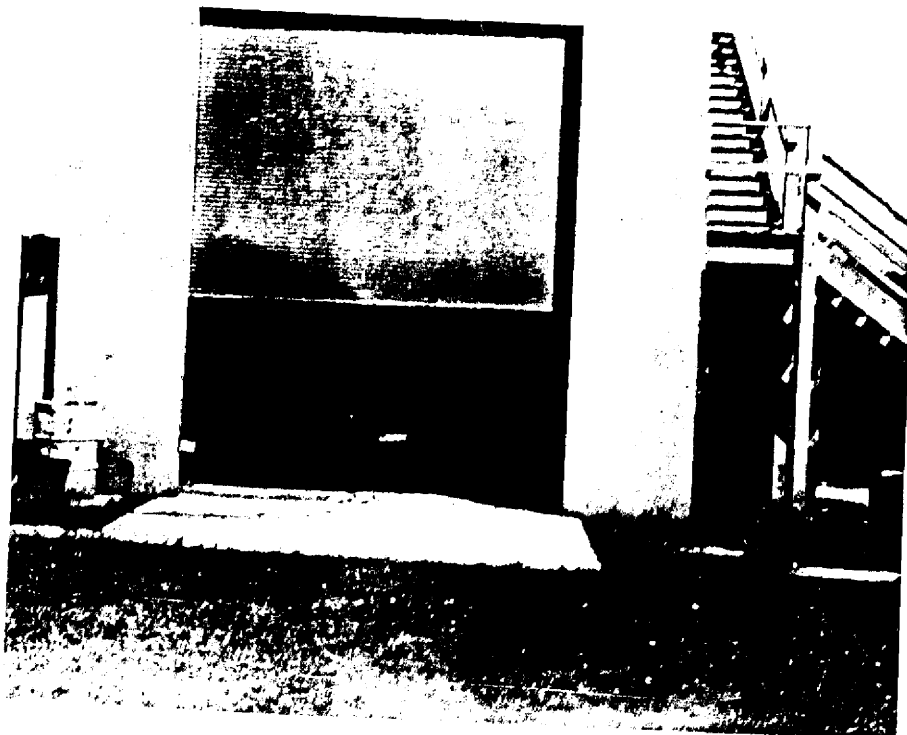
CLASSIFICATION	000	<input checked="" type="checkbox"/> INFORMATION
PHOTOGRAPHER	CCE	<input type="checkbox"/> PICTORIAL
		<input type="checkbox"/> PROGRESS _____ %
<u>13-35-12-12</u>	<u>7-30-59</u>	<u>Ponape</u>
NEGATIVE NO.	DATE	SITE
WEATHER STATION

1. The weather station building, which is being operated by the U.S. Weather Bureau, appears to be in very good condition structurally. A small amount of dry rot occurs at the base of the stair posts and Mr. Hirada intends to have the posts incased in concrete approximately 12" above the footings. During windy rainstorms, a small portion of the roof develops slight leaks. This he proposes to repair with mastic and metal flashing. Mr. Hirata further proposes to build a small shelter to house an emergency generator. This will keep the station operable during power failures at the main plant.

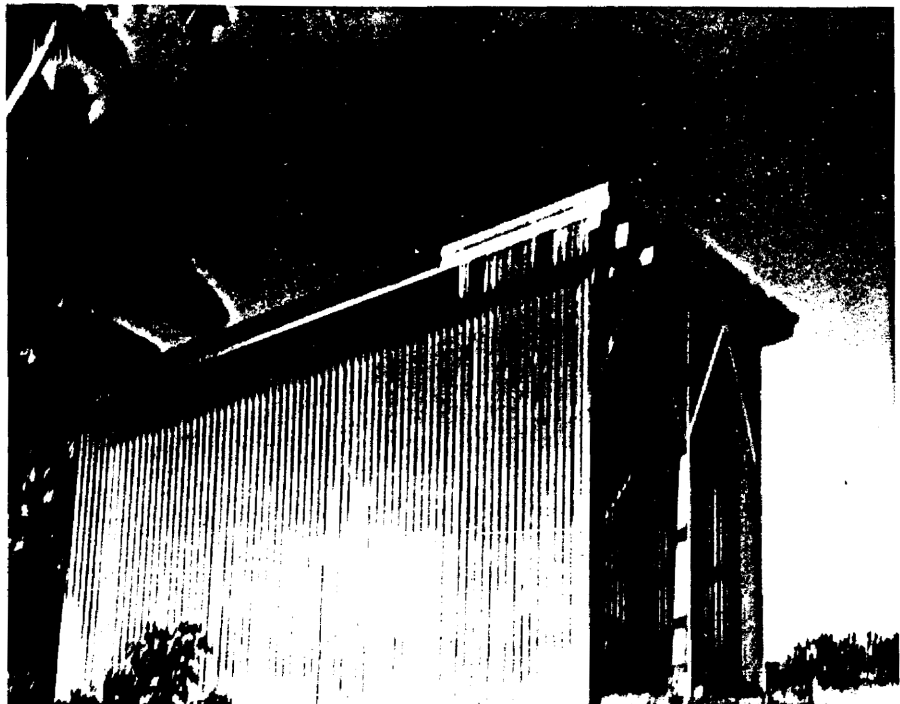
CLASSIFICATION	CUO	<input checked="" type="checkbox"/> INFORMATION
PHOTOGRAPHER	COB	<input type="checkbox"/> PICTORIAL
		<input type="checkbox"/> PROGRESS _____ %
13-35-12-15	8-1-59	Kapingamarangi
NEGATIVE NO.	DATE	SITE
VIEW OF ROOF SECTION LOSING FROM US CORNER ROOF

1. PUMP HOUSE - Slight weather damage to roof, one section of aluminum sheathing missing and one aluminum window shutter is hanging by one hinge. Otherwise in good condition.

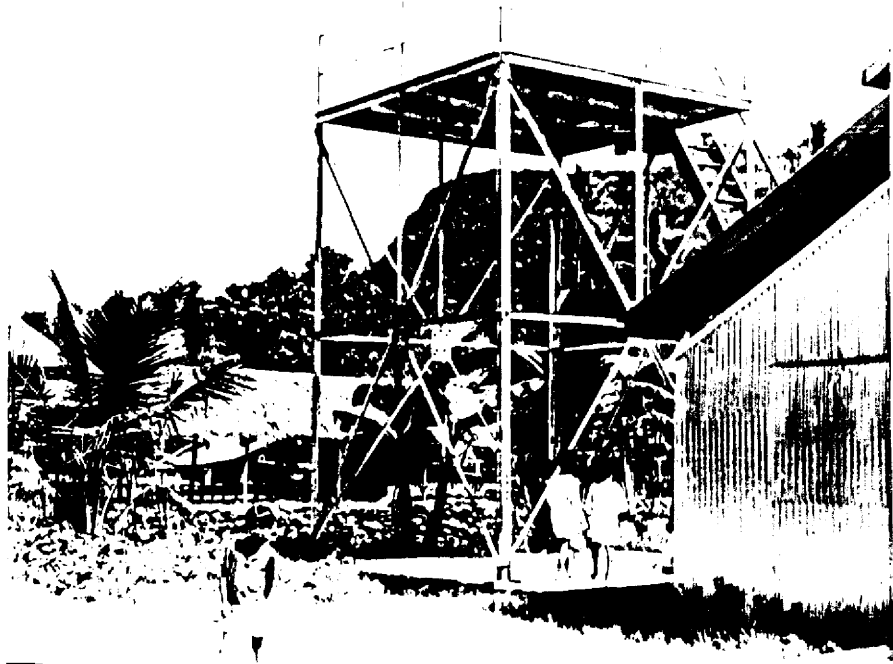
CLASSIFICATION	000	<input checked="" type="checkbox"/> INFORMATION
PHOTOGRAPHER	COE	<input type="checkbox"/> PICTORIAL
		<input type="checkbox"/> PROGRESS _____ %
<u>13-35-13-3</u>	<u>8-2-59</u>	<u>KUSAIN</u>
NEGATIVE NO.	DATE	SITE
RANIRSONDE TOWER		SITE "A"

1. SUPPLY & OPERATIONS - In good condition.
2. GENERATOR SHED - In good condition.
3. RAWINSONDE TOWER - In good condition. However the vertical steel poles and steel angles are beginning to show signs of rust.
4. PIT LATRINE - Apparently good condition, but should be replaced.
5. FUEL TANK BASE - In good condition.
6. REEFER SHED - In good condition.

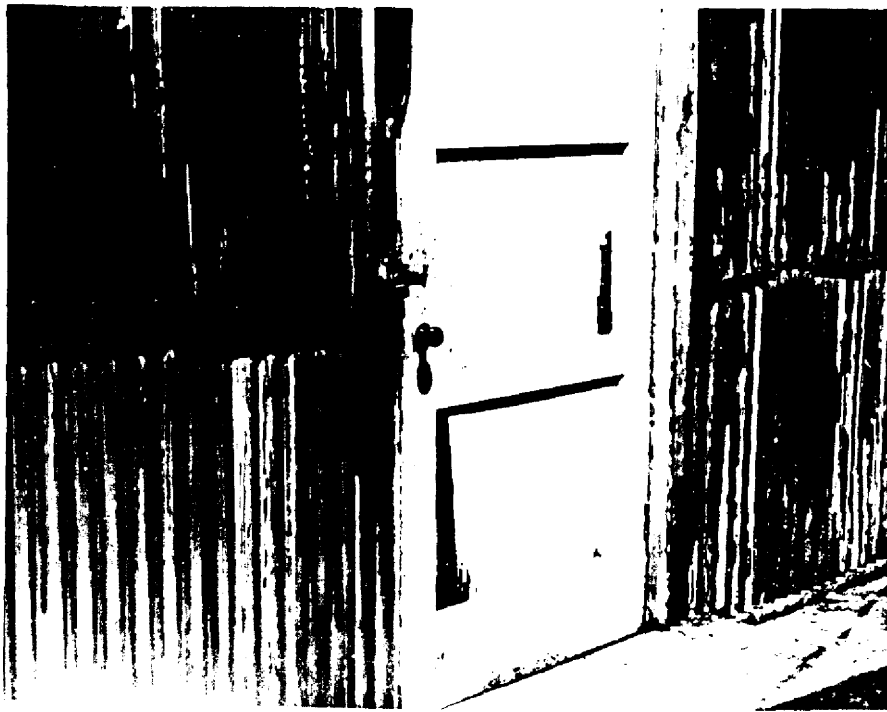
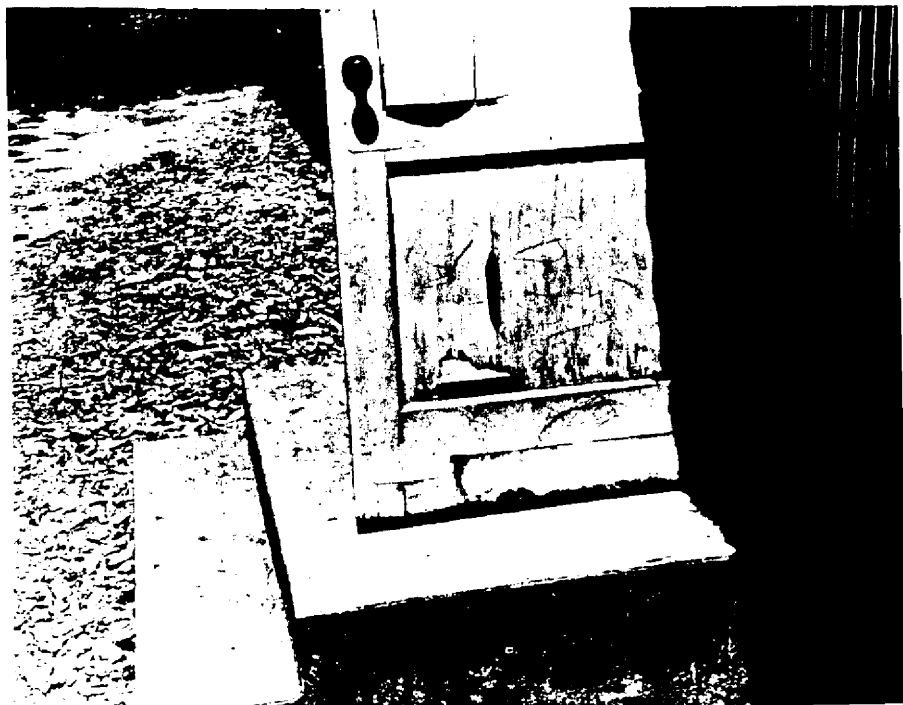
CLASSIFICATION	000	<input checked="" type="checkbox"/> INFORMATION
PHOTOGRAPHER	CCB	<input type="checkbox"/> PICTORIAL
		<input type="checkbox"/> PROGRESS _____ %
13-35-13-15	8-2-59	Kusala
NEGATIVE NO.	DATE	SITE
VIEW OF DOOR SW END MESSHALL SITE "B"

1. REEFER SHED - In good condition.
2. MESS HALL - Two of the doors are beyond repair due to dry rot and need to be replaced. A screen is missing from one window. Otherwise the building is in good condition.
3. DAY ROOM - Is in good condition.
4. BARRACKS - Is in good condition.
5. BARRACKS - Is in good condition.
6. POWER HOUSE - Is in good condition.
7. DISTILLATION SHED - Is in good condition.
8. WATER TOWER - There is evidence of dry rot in the bottom 6 inches of each of the tower legs. Also, several planking are missing from the platform. Repairs could be easily made to place the tower in good working condition.
9. BARRACKS - In good condition, except for one door which is beyond repair with dry rot and needs to be replaced.
10. ANTENNA POLES - In good condition.
11. SEWER OUTFALL - Has disappeared and needs to be replaced.

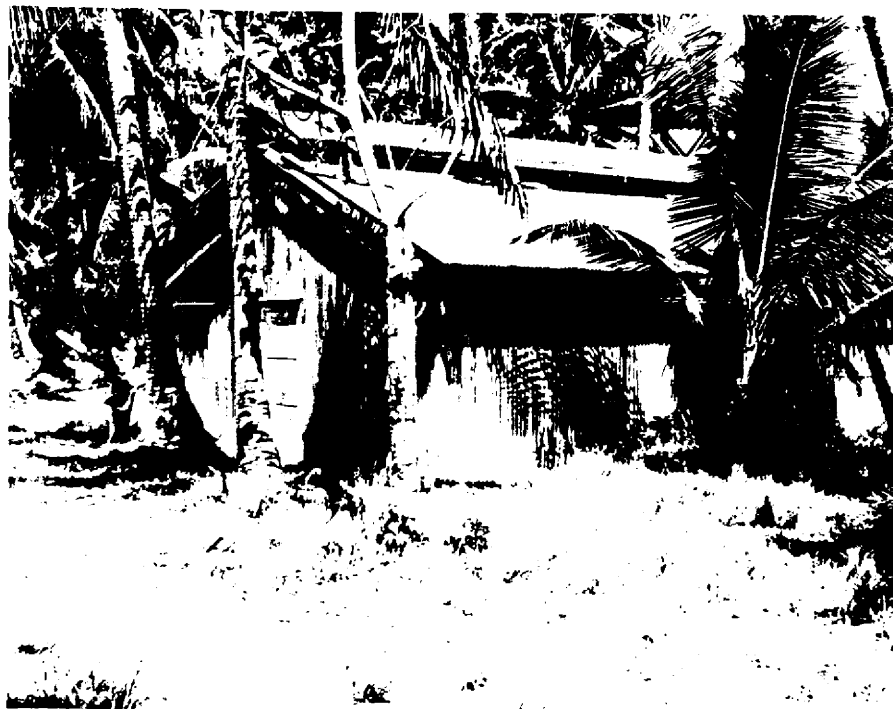
CLASSIFICATION	000	<input checked="" type="checkbox"/> INFORMATION
PHOTOGRAPHER	COE	<input type="checkbox"/> PICTORIAL
		<input type="checkbox"/> PROGRESS _____ %
<u>13-35-14-2</u>	<u>8-3-59</u>	<u>Utirik</u>
NEGATIVE NO.	DATE	SITE
BARRACKS BLDG. # 2

1. BARRACKS #1 - In good condition.
2. BARRACKS #2 - In good condition except for one shutter hinge missing.
3. DAY ROOM - In good condition.
4. PUMP SHED - In good condition.
5. OPERATIONS & SUPPLY - In good condition.
6. RAWINSONDE PAD - In good condition.
7. REEFER BANKS - In good condition.
8. MESS HALL - In good condition.
9. WATER TOWER - In good condition.
10. POWER & DISTILLATION - In good condition.
11. ANTENNA POLES - In good condition.
12. PIER - In fair, useable condition.

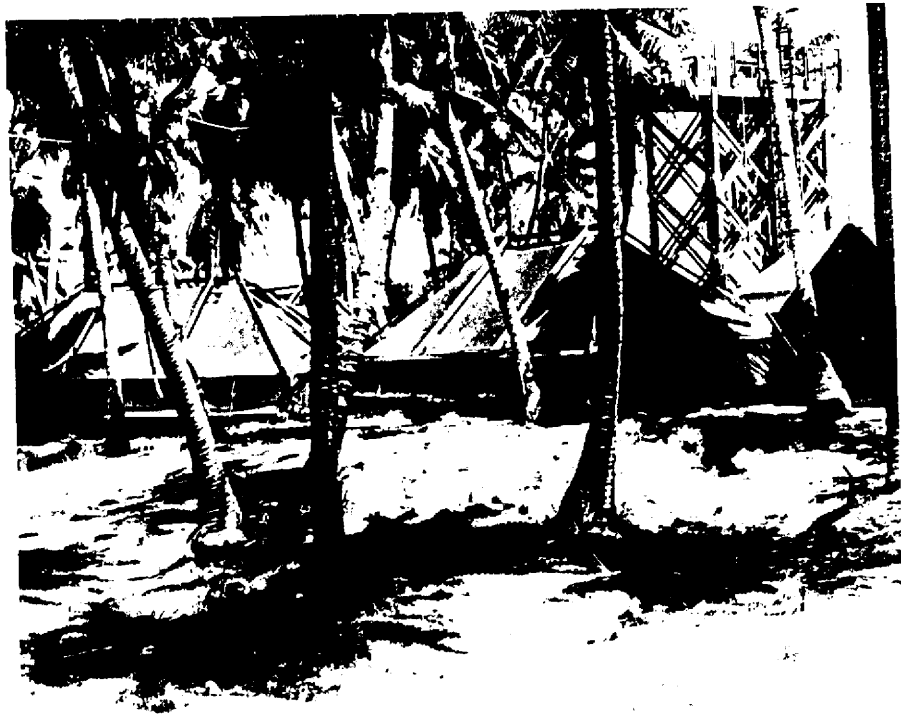
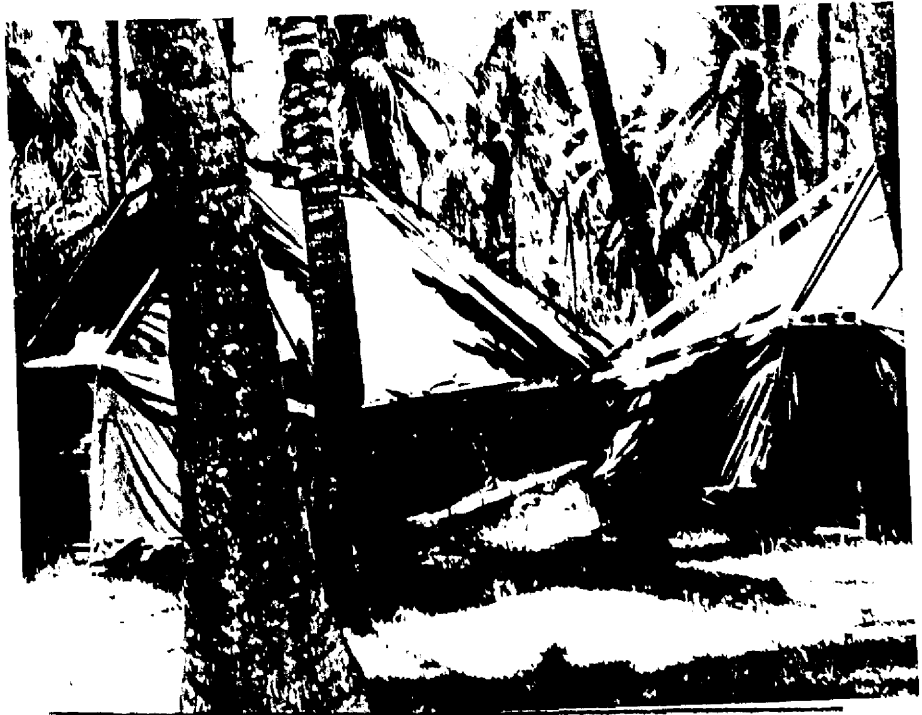
1. DAY ROOM - Frame in good condition. Needs new tent and fly.
2. TENT #1 - DITTO
3. TENT #2 - DITTO
4. TENT #3 - DITTO
5. MESS HALL - Frame in good condition. Needs new tent and fly and screened.
6. REEFER TENT - DITTO
7. RAD-SAFE TENT - Frame in good condition. Needs new tent and fly.
8. POWER & DISTILLATION - In good condition.
9. PIT LATRINE - Fair condition but should be replaced.
10. FIELD SHOWER - Frame in good condition. Needs canvas siding.
11. PUMP HOUSE - In good condition.
12. WATER TOWER - In good condition.
