JOINT TASK FORCE SEVEN  
TASK GROUP 7.3  
APO 187, c/o Postmaster  
San Francisco, California

22 March 1954

Subj: Radioactive Contamination of Ships and Radiological Exposure of Personnel of Task Group 7.3 due to BRAVO, the First Nuclear Explosion of CASTLE

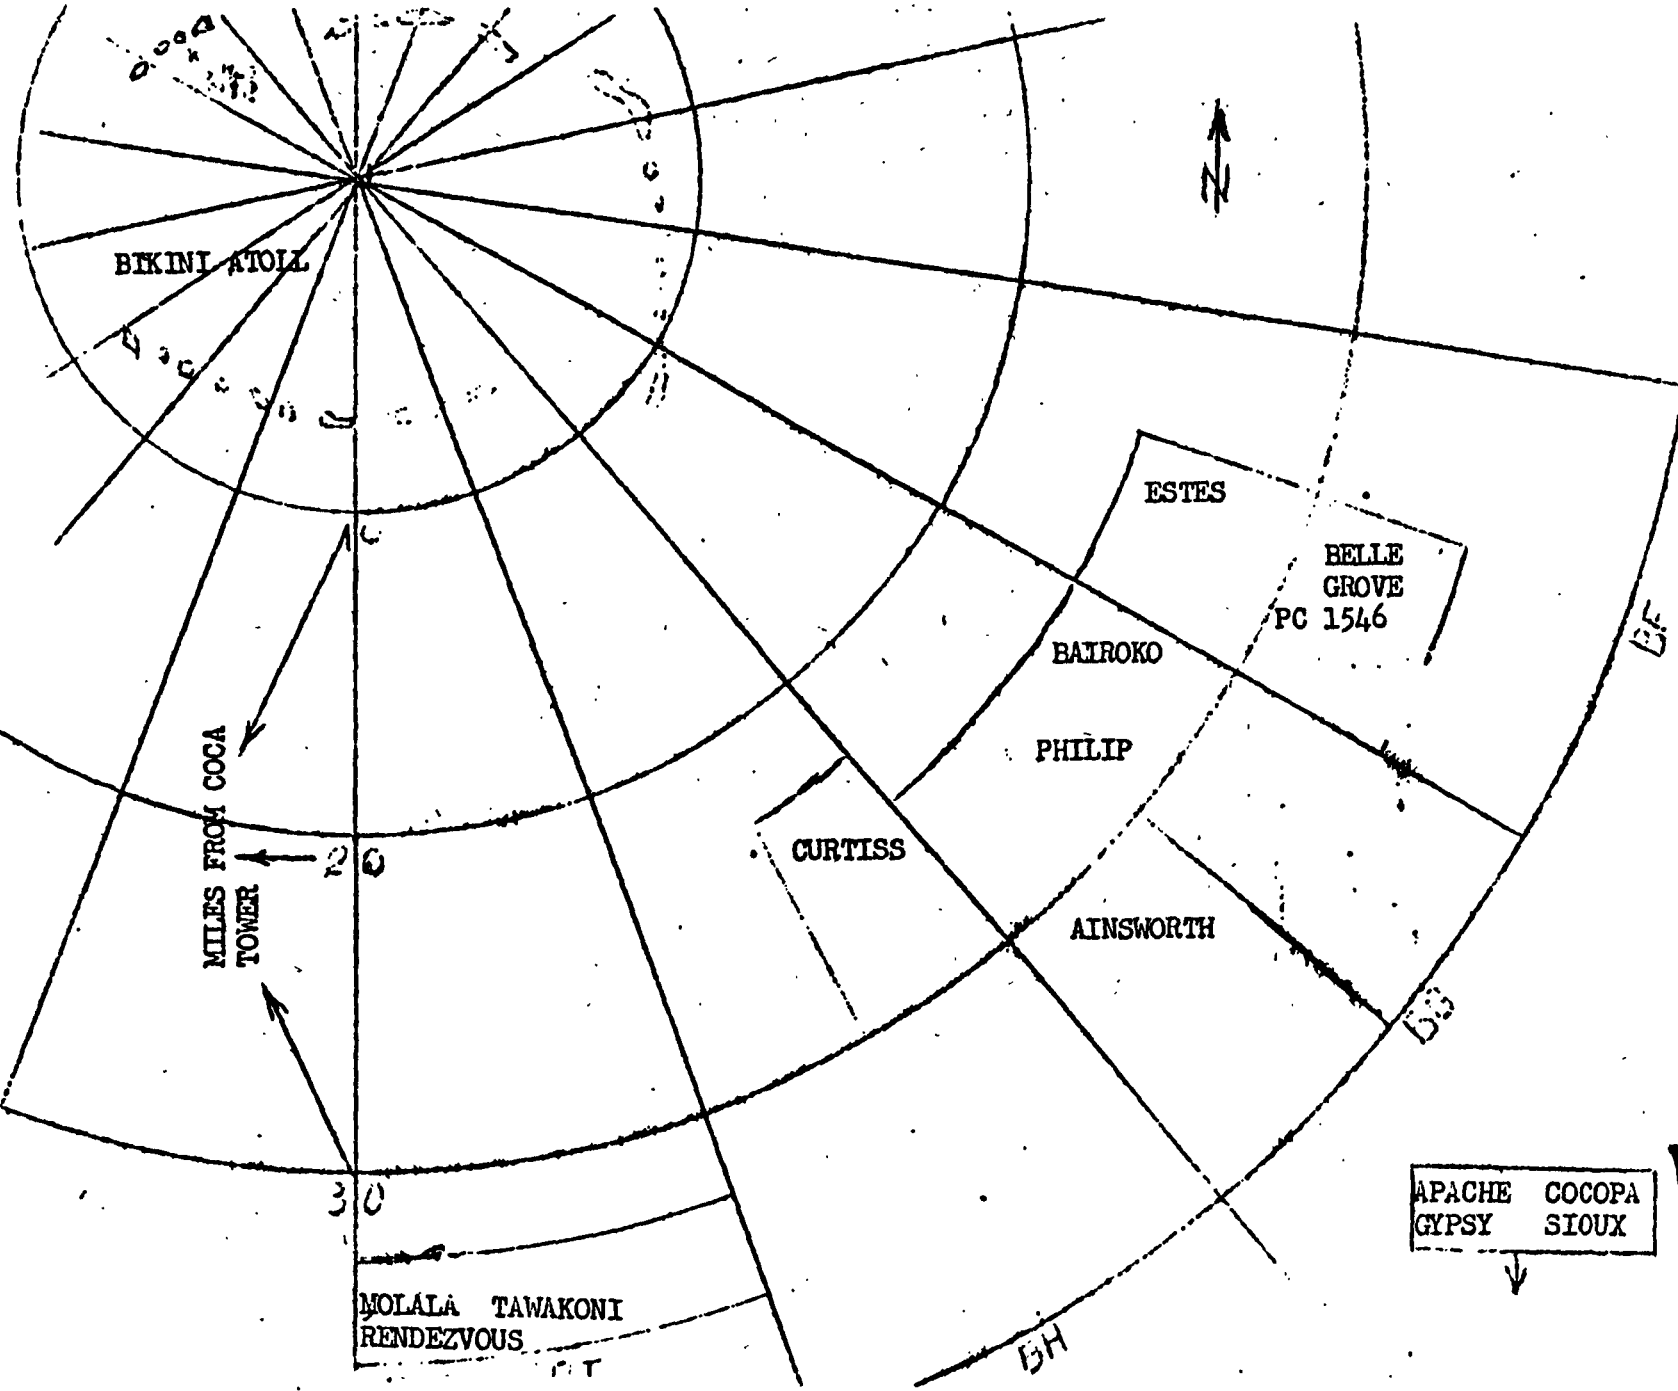
Declassified  
ENCL (1) DOD DIR 5200.10

2. Commencing about 0800M, highly radioactive, visible, white particles, about the size of pinheads, began to fall on BAIROKO, PHILIP, ESTES and CURTISS. At this time BAIROKO was about 31 miles from ground zero. In spite of the continuous use

of their washdown systems, concentrations of up to several roentgens per hour built up on BAIROKO and PHILIP (plane guard for BAIROKO), with average readings reaching 500 and 750 milliroentgens per hour, respectively. The fallout pattern was not symmetrical, since both ESTES and CURTISS, approximately the same distance from ground zero as BAIROKO but on opposite sides of her, received less contamination. Other ships, including those which had been moved southward before the detonation, received none of this early fallout.

Positions of TG 7.3 ships from BRAVO Hour until about 0815, 1 March 1954
