AN
INSPECTION REPORT
OF
WEATHER AND RAD-SAFE STATIONS

30 July Thru 3 August 1959

From: E. H. Willes, Resident Engineer Re: Report and Log of Inspection of
[Signature] Weather and Rad-Safe Stations at
Ujelang, Ponape, Kapingamarangi
Kusaie, Utirik, and Wotho.

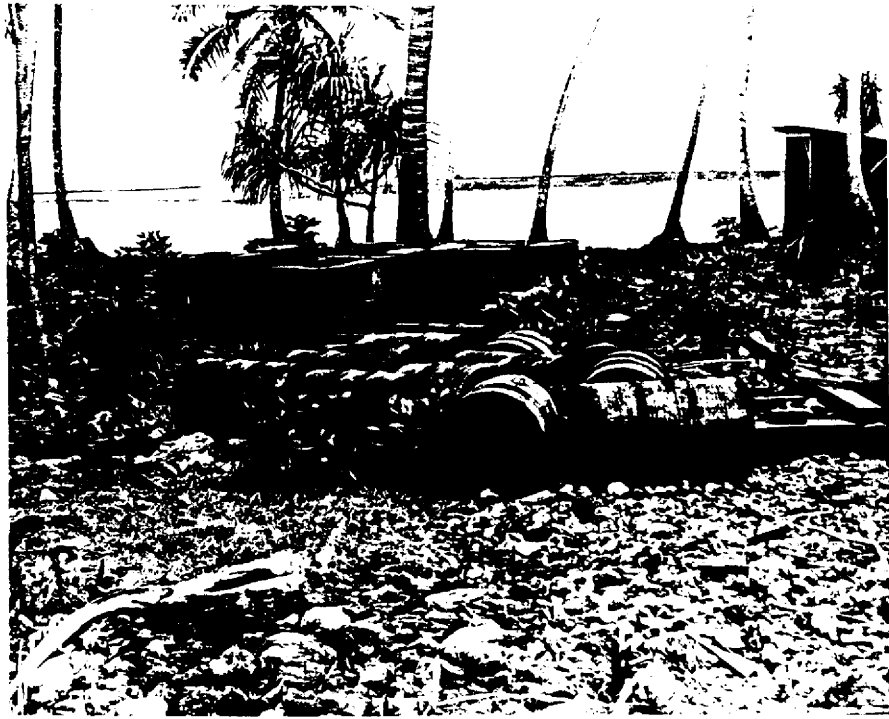
CLASSIFICATION	030	<input checked="" type="checkbox"/>	INFORMATION
PHOTOGRAPHER	COE	<input type="checkbox"/>	PICTORIAL
		<input type="checkbox"/>	PROGRESS.....%
<u>13-35-12-10</u>	<u>7-30-59</u>	<u>Ujelang</u>	
NEGATIVE NO.	DATE	SITE

1. WATER TOWER - In fair condition - reusable for at least one more year from this date.
2. POWER & DISTILLATION - Fairly good condition - One aluminum shutter is missing and requires replacement. Small area of fire damage noted between generator locations. Not serious.
3. SHOWER - Building frame & piping reusable - Needs new canvas siding.
4. DAY ROOM - Frame in good condition and new tent & fly is required.
5. LIVING QUARTERS - Frame in good condition - New tent & fly required.
6. REEFERS & LAUNDRY - Frame in good condition - New tent & fly required.
7. MESS HALL - In fair condition - needs new tent & fly and new screens throughout.
8. LIVING QUARTERS - Frame in good condition - new tent & fly required.
9. RAD-SAFE TENT - Frame in good condition - new tent & fly required.
10. PIT LATRINE - Fair condition, but should be replaced.
11. PUMP HOUSE - In fair condition.

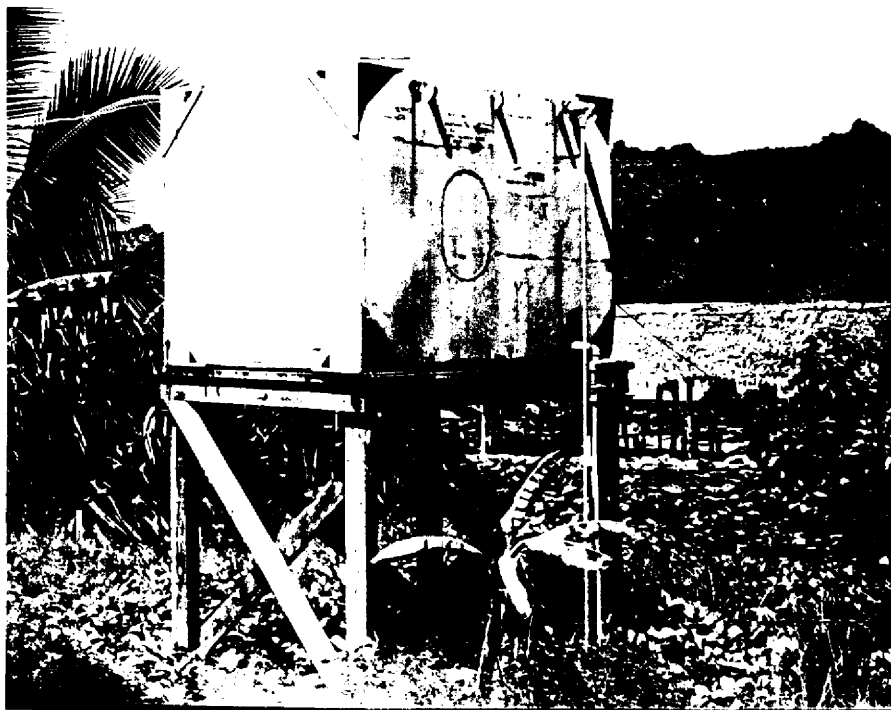
CLASSIFICATION	OUO	<input checked="" type="checkbox"/> INFORMATION
PHOTOGRAPHER	COB	<input type="checkbox"/> PICTORIAL
		<input type="checkbox"/> PROGRESS _____ %
<u>13-35-13-7</u>	<u>8-2-59</u>	<u>Rusale</u>
NEGATIVE NO.	DATE	SITE
FUEL TANK & BASE		SITE "A"

1. SUPPLY & OPERATIONS - In good condition.
2. GENERATOR SHED - In good condition.
3. RAWINSONDE TOWER - In good condition. However the vertical steel poles and steel angles are beginning to show signs of rust.
4. PIT LATRINE - Apparently good condition, but should be replaced.
5. FUEL TANK BASE - In good condition.
6. REEFER SHED - In good condition.

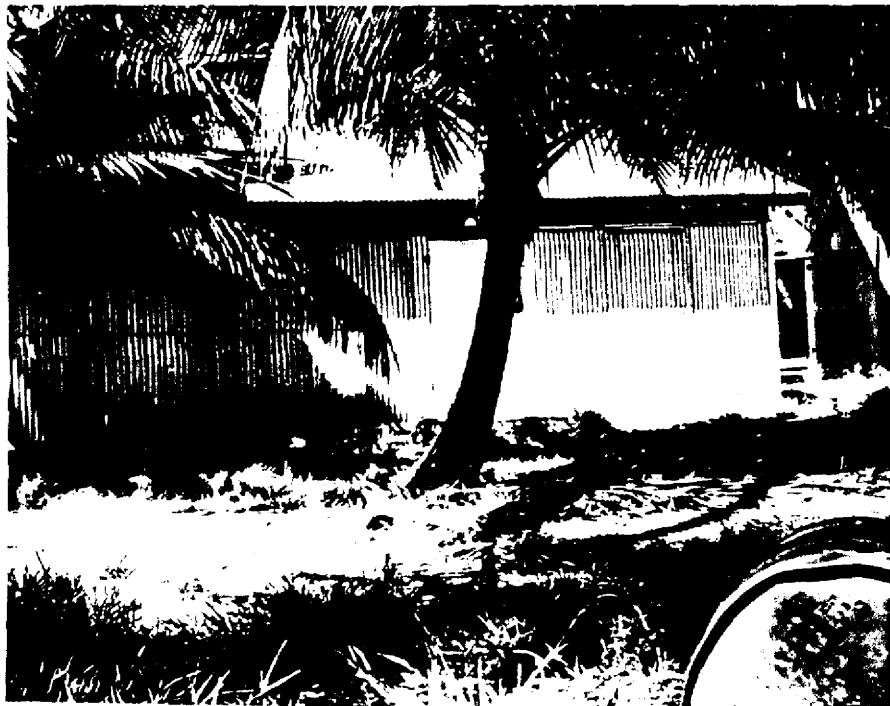
CLASSIFICATION	000	<input checked="" type="checkbox"/> INFORMATION
PHOTOGRAPHER	COE	<input type="checkbox"/> PICTORIAL
		<input type="checkbox"/> PROGRESS _____ %
<u>13-35-14-1</u>	<u>8-3-59</u>	<u>Utirik</u>
NEGATIVE NO.	DATE	SITE
BARRACKS BLDG. # 1

1. BARRACKS #1 - In good condition.
2. BARRACKS #2 - In good condition except for one shutter hinge missing.
3. DAY ROOM - In good condition.
4. PUMP SHED - In good condition.
5. OPERATIONS & SUPPLY - In good condition.
6. RAWINSONDE PAD - In good condition.
7. REEFER BANKS - In good condition.
8. MESS HALL - In good condition.
9. WATER TOWER - In good condition.
10. POWER & DISTILLATION - In good condition.
11. ANTENNA POLES - In good condition.
12. PIER - In fair, useable condition.

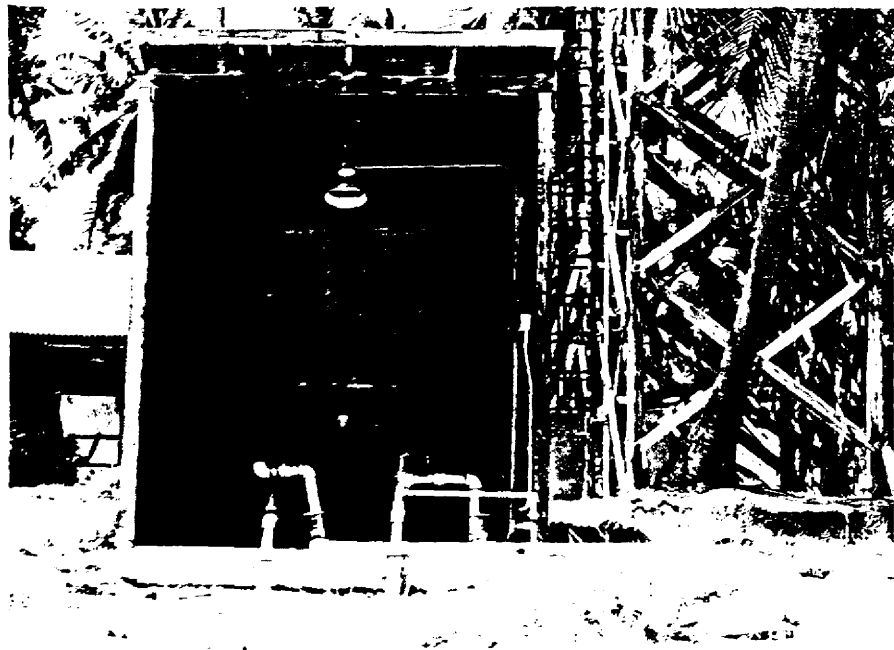
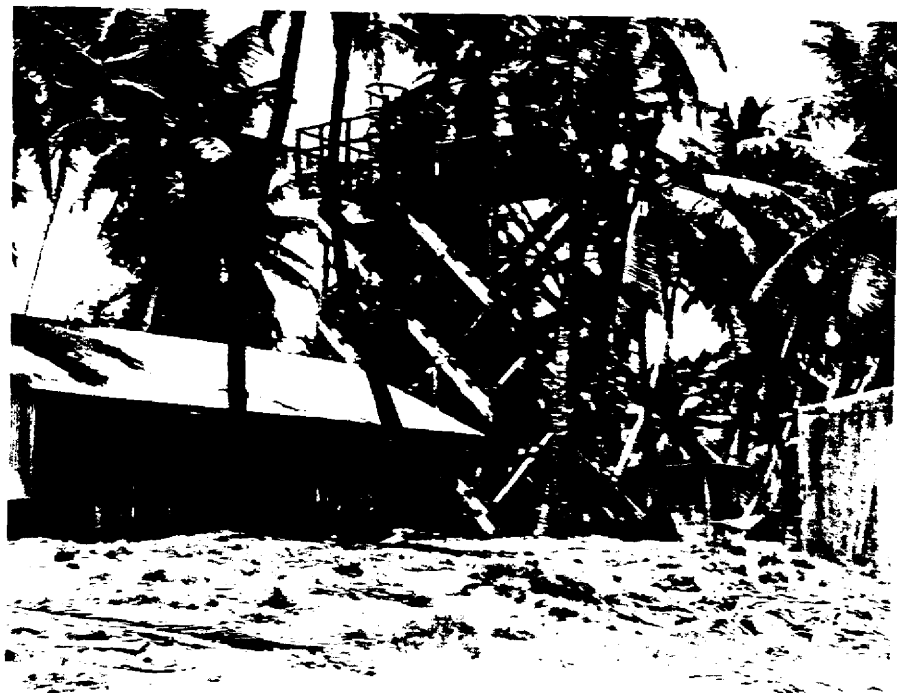
CLASSIFICATION	GOO	<input checked="" type="checkbox"/> INFORMATION
PHOTOGRAPHER	CCB	<input type="checkbox"/> PICTORIAL
		<input type="checkbox"/> PROGRESS
13-35-14-18	8-3-59	WATER
NEGATIVE NO.	DATE	SITE
WATER TOWER

1. DAY ROOM - Frame in good condition. Needs new tent and fly.
2. TENT #1 - DITTO
3. TENT #2 - DITTO
4. TENT #3 - DITTO
5. MESS HALL - Frame in good condition. Needs new tent and fly and screened.
6. REEFER TENT - DITTO
7. RAD-SAFE TENT - Frame in good condition. Needs new tent and fly.
8. POWER & DISTILLATION - In good condition.
9. PIT LATRINE - Fair condition but should be replaced.
10. FIELD SHOWER - Frame in good condition. Needs canvas siding.
11. PUMP HOUSE - In good condition.
12. WATER TOWER - In good condition.
