File Name (TITLE): The Radiological Cleanup  
of Aenwetab Atoll, Excerpts.

THE FOLLOWING pages (i.e.,  
444-471, inclusive) are  
EXCERPTS from the book  
entitled, "THE RADIOLOGICAL  
CLEANUP OF ENEWETAK ATOLL",  
By THE DEFENSE NUCLEAR  
Agency, 1981. THE FORWARD  
IS ALSO INCLUDED TO PROVIDE  
OBJECTIVES OF Book. THIS IS THE  
BEST Running Description ON THE  
SUBJECT OF DISCONTINUATION OF  
RUNIT CLEANUP by the Defense  
Nuclear Agency FOUND TO DATE.

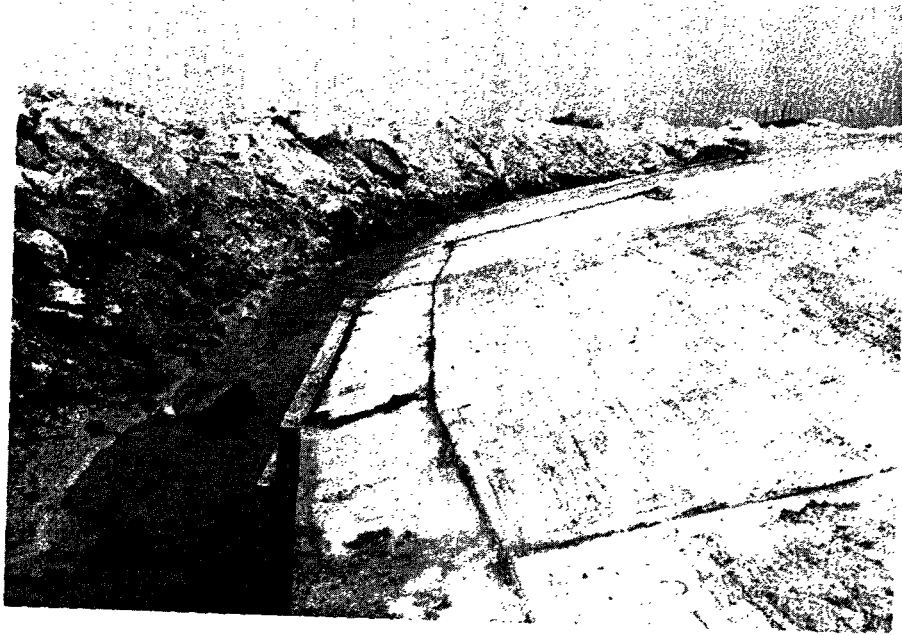
FIGURE 8-43. KEYWALL EXPANSION JOINT.

The dome cap was designed to protect the mound of contaminated material from natural erosion by wind and water. The POD design prescribed a nonload-bearing surface of 18 inches of concrete with the same strength characteristics as the keywall. Reinforcement was not prescribed because the concrete was to be produced using salt water, which accelerates corrosion of ferrous reinforcing materials. The final design of the cap sections was left to the USAE. In keeping with good engineering practices, it was decided that each cap section should be as close to square as possible to minimize shrinkage cracking. The USAE decided to place approximately 20-by-20-foot sections in the first ring, and continue with that size until the shape of the dome dictated a reduction in size to keep the square shape of the individual sections. Each cap section was keyed to adjacent sections using forming techniques. The POD design required expansion joint material only where the first ring joined the keywall (Figure 8-43). The rings were designated by the letters "A" through "K," beginning at the keywall and extending up to the top of the dome.

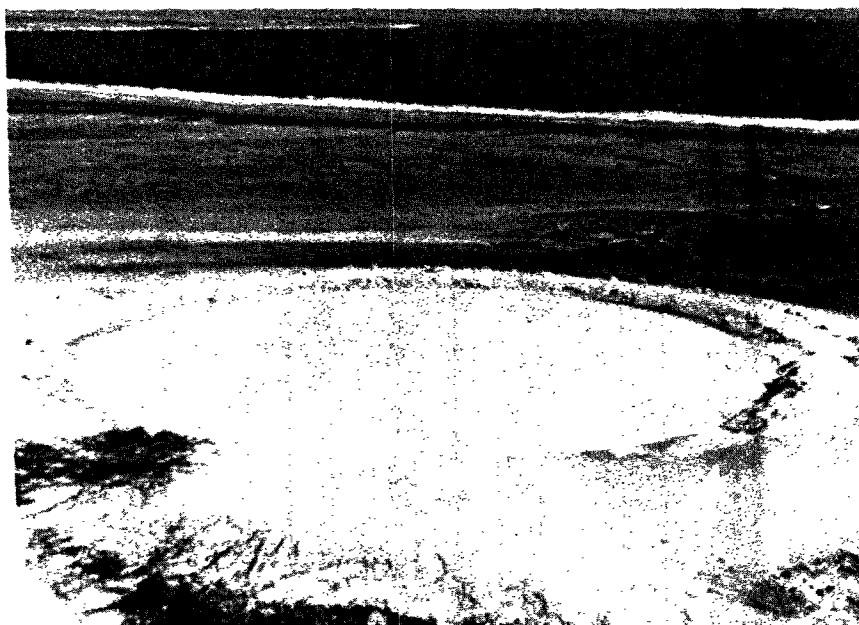
FIGURE 8-52. SECOND EXTENSION, CACTUS CRATER STRUCTURE.

them in concrete bunkers,<sup>137</sup> Field Command established a disposal policy for any additional red debris on 17 December 1979.<sup>138</sup> Red debris was to be encapsulated in another section to be added to the lagoon side of the Cactus Crater extension. The new section would be designed to hold all red debris on hand and any additional debris that might appear through March 1980, and would be capped with an 18-inch concrete cover. Red debris would be collected and stockpiled until mid-February, at which time the USAE would construct the container and encapsulate the debris on hand. Space would be left unfilled to allow for encapsulation of any debris discovered after military forces were drawn down in February. At the end of March, just prior to project completion, the base support contractor would encapsulate any debris on hand and cap the new annex, conforming with the design and aesthetics of the previous extension. The second extension was constructed in February 1980 and consisted of approximately 13 cubic yards of space. Approximately 4 cubic yards of red debris were enclosed and slurried in place. On 31 March 1980, H&N returned to Runit, encapsulated an additional cubic yard of debris which had been collected in the interim, and capped the facility (Figure 8-52).
