Technical Report

activity. The base facilities considered to be permanent for the Pacific Proving Ground are located on sites Elmer and Fred at Eniwetok Atoll. In order to provide accommodations for the anticipated population, including a new peak high of 3,000 men on Fred, it was determined that certain changes would have to be made to existing facilities. On Elmer these changes con-sisted of: additions to the laundry and mess hall, an engineering wing on the administration building, a personnel wing for the administration building, new barracks, an additional 1000 KW generator in the power house, additional distillation equipment, and a general revision to the power supply and distribution systems of both sites, including a submarine power cable between Elmer and Fred,

CHAPTER II, SECTION 1

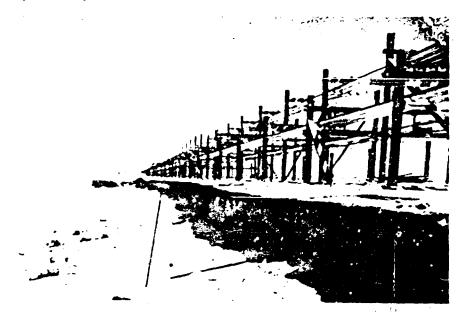
Figure 2 213. Charlie Causeway - Erosion from Wave Action

Grading was completed on 5 September 1953, driving of rail for the bulkheads completed on 12 September 1953, and all timbering and backfill were completed early in October. Figure 2-213 shows a typical example of erosion due to wave action on the ocean side. This photograph was taken on 4 December $1 \rightarrow 0$ in the lagoon side the bulkheads experience damage due to tidal action. Figure 2-214 side typical example in this respect.
